Technical Paper by R.P. Hillman and T.D. Stark

SHEAR STRENGTH CHARACTERISTICS OF PVC GEOMEMBRANE-GEOSYNTHETIC INTERFACES

ABSTRACT: Torsional ring shear and large-scale direct shear tests were conducted to investigate the shear behavior of polyvinyl chloride (PVC) geomembrane-geosynthetic interfaces. Specifically, the smooth and faille-finished sides of a 0.75 mm-thick PVC geomembrane were sheared against five different nonwoven geotextiles, a drainage composite, a geonet, and an unreinforced geosynthetic clay liner (GCL). Test results indicate that the smooth side of the PVC geomembrane yields a higher interface shear resistance than the faille-finished side due to the larger contact area and higher pliability of the smooth side. The interface shear behavior of the PVC geomembrane is compared to that of a high density polyethylene (HDPE) geomembrane and two very flexible polyethylene (VFPE) geomembranes. Faille-finished PVC geomembrane-nonwoven geotextile interfaces experience a post-peak strength loss of less than 25% at normal stresses between 100 and 400 kPa and no post-peak strength loss at normal stresses of 50 kPa and below. This behavior is attributed to the pliability of

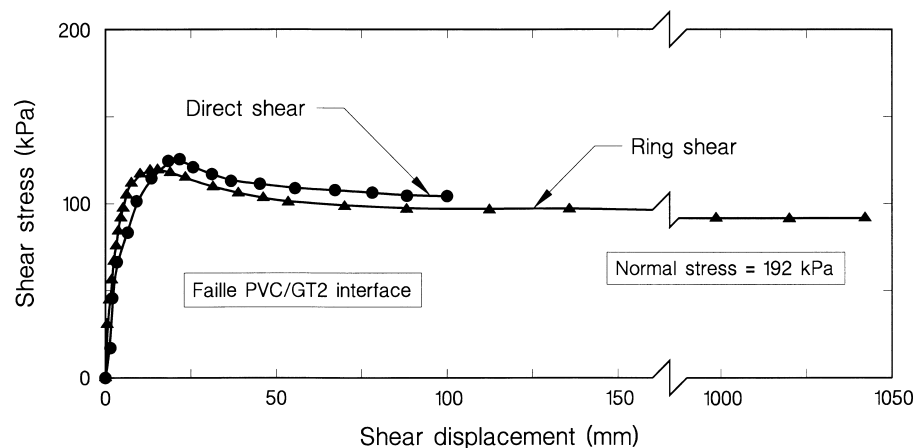
Figure 1. Comparison of shear stress-displacement relationships from ring shear and direct shear tests on a faille PVC geomembrane-GT2 geotextile interface.

ships obtained from ring shear and direct shear tests on a faille PVC geomembrane-GT2 geotextile interface at a normal stress of 192 kPa. It can be seen that both test procedures produce similar shear stress-displacement relationships. The ring shear test yielded secant peak and residual friction angles of approximately 32 and 26°, respectively, while the direct shear test yielded corresponding values of 34 and 28°, respectively. This agreement between the ring shear and direct shear test results on the faille PVC geomembrane-GT2 geotextile interface is typical for all of the interfaces that were compared (Table 3). The main difference between the ring shear and direct shear test methods is in the values obtained for the residual friction angle and shear displacement at the residual strength. The direct shear test terminates at a shear displacement of approximately 100 mm and, thus, the resulting friction angle is greater than the ring shear residual friction angle for many interfaces. Direct shear tests were conducted at one normal stress for each interface (either 192 or 200 kPa). Only one normal stress was tested because the focus of the present paper is PVC geomembrane-geosynthetic interface shear behavior, not a comparison of ring shear and direct shear test methods. Direct shear testing is being conducted at other normal stresses and the results will be the subject of a subsequent paper that compares the two devices. One normal stress was used to show agreement between the two testing methods, then, the more efficient ring shear device was used to obtain the test results that comprise the databases of Tables 1 and 2. Discussion of the ring shear data in Tables 1 and 2 is the focus of the remainder of the present paper.

Figure 1 presents a comparison between the shear stress-displacement relation-

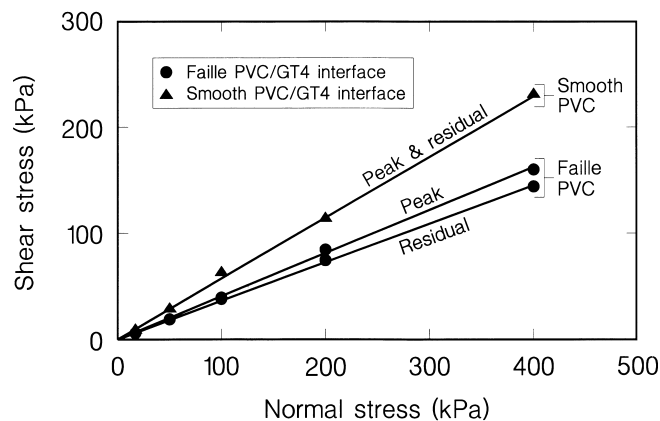
Shear tests were performed to determine the effect of a faille finish on the shear strength of PVC geomembrane-nonwoven geotextile interfaces. **Figure 2** shows the peak and residual failure envelopes for the smooth and faille sides of the PVC geomembrane sheared against the GT4 nonwoven geotextile. It is evident that the smooth side of the PVC geomembrane yielded significantly higher peak and residual interface shear strengths than the faille side. Furthermore, no noticeable post-peak strength loss was observed for the smooth PVC geomembrane interface, and the peak and residual failure envelopes are essentially the same. For example, at a normal stress of 200 kPa, the smooth PVC interface had a secant peak and residual friction angle of 30°. At this same normal stress, the faille PVC interface yielded secant peak and residual friction angles of 23 and 20°, respectively.

Figure 2. Comparison of failure envelopes for smooth and faille PVC geomembrane-GT4 geotextile interfaces.

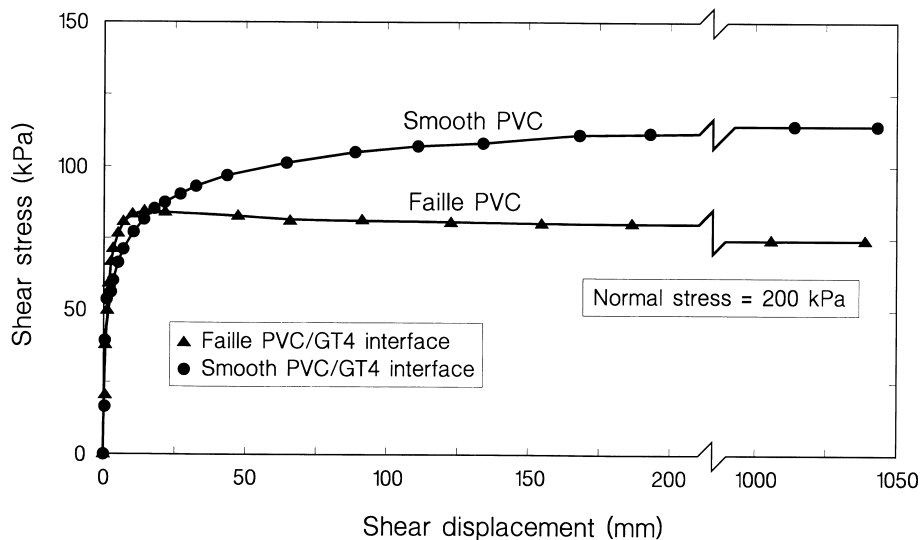
The post-peak shear behavior is further illustrated by the shear stress-displacement relationships shown in **Figure 3**. The faille PVC interface reached a peak strength condition and then experienced a post-peak strength loss of approximately 10%. However, the smooth PVC geomembrane interface exhibited a peak shear strength that was roughly 30% higher than that for the faille side and it reached this peak strength at a larger shear displacement. The smooth PVC geomembrane interface was tested to over 1,000 mm of shear displacement and no post-peak strength loss was observed. The higher frictional strength of the smooth side of a PVC geomembrane is attributed to its

Figure 3. Comparison of shear stress-displacement relationships for smooth and faille PVC geomembrane-GT4 geotextile interfaces.

larger contact area and higher surface pliability than the faille side. The increased pliability results in a more ductile, malleable, or adaptable surface than the faille side. The difference in surface pliability is attributed to the embossing process, which results in the embossed pattern creating a less pliable surface. The smooth side allows for a greater area of contact between it and the other interface component because it does not possess the surface depressions of the faille side, which decrease the interface contact area. The faille side was estimated to have a contact surface area that is 20 to 30% lower than that of the smooth side because of the embossing. Furthermore, as shearing progresses, the higher surface pliability of the smooth side allows it to be: (1) roughened, and (2) embedded into by the other interface component, resulting in a larger shear resistance. The faille side also possesses a high pliability compared to an HDPE geomembrane; however, the other interface component cannot roughen and embed into the faille side as much as it can on the smooth side. This prevents the frictional resistance of the faille side from reaching that of the smooth side. This was evident from striations on the smooth side after shearing at all normal stresses (17 to 400 kPa). In contrast, the faille side did not exhibit any striations except after tests at normal stresses of 200 and 400 kPa.

In summary, the higher surface pliability of the smooth side enables the strength-increasing mechanisms discussed above to develop more readily than on the faille side, which accounts for the larger shear strength of the smooth side. This also explains why no post-peak strength loss was observed for the smooth PVC geomembrane-nonwoven geotextile interfaces. The strength-increasing mechanisms offset the strength-reducing effects, such as geotextile fibers being pulled or torn out, thereby preventing a loss of interface shear resistance with increasing shear displacement. This was not

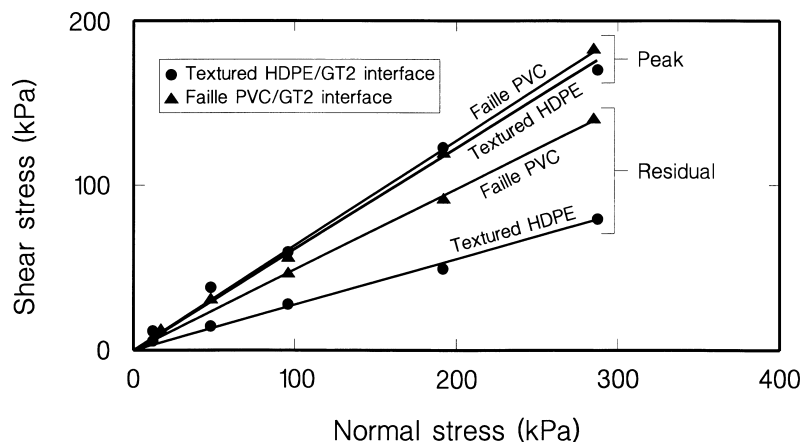
Figure 4. Comparison of failure envelopes for faille PVC and textured HDPE geomembrane-GT2 geotextile interfaces.

The peak and residual friction angles of textured and smooth HDPE geomembrane interfaces are compared to those of the faille PVC geomembrane interfaces in Tables 1 and 2, respectively. Additionally, peak and residual failure envelopes for faille PVC and textured HDPE geomembrane-GT2 nonwoven geotextile interfaces are shown in **Figure 4**. It can be seen that these two interfaces have similar peak failure envelopes. However, there is a significant difference in the post-peak strength loss experienced by the interfaces, as reflected in the residual failure envelopes. Specifically, the textured HDPE geomembrane interface underwent a larger post-peak strength loss compared to the faille PVC geomembrane interface. Stark et al. (1996) showed that a variety of textured HDPE geomembrane-nonwoven geotextile interfaces experienced a similar (50 to 60%) post-peak strength loss. The reason for this large strength loss is that the asperities of the textured HDPE geomembrane tore or pulled out the fibers of the geotextile and the geomembrane texturing was smoothed or polished (Stark et al. 1996). On the

other hand, the faille PVC geomembrane tore or pulled out only a small quantity of fibers from the geotextile, which allowed the geotextile to stay relatively intact and maintain the interface strength. The failed specimens from the textured HDPE geomembrane-nonwoven geotextile interface tests reported by Stark et al. (1996) had been archived and were directly compared with the new PVC geomembrane-nonwoven geotextile interface test specimens to estimate the damage to the nonwoven geotextiles. After observing the small quantity of fibers that were removed from the geotextile by the PVC geomembrane, it could not be determined whether the fibers were torn from or pulled out of the geotextile. At normal stresses of 48 kPa and below, the PVC geomembrane extracted few, if any, fibers because the geotextile was unable to sufficiently embed into the PVC geomembrane. As a result, there was no noticeable post-peak strength loss at these normal stresses. In fact, a trend of no post-peak strength loss at low normal stresses was observed for all of the PVC geomembrane-nonwoven geotextile interfaces tested. This behavior has important design implications that are discussed below. At normal stresses between 96 and 285 kPa, the residual shear strength of the PVC geomembrane interface was only approximately 15 to 25% lower than its peak shear strength. These characteristics suggest that PVC geomembranes are well suited for applications in which low normal stresses are expected, such as landfill cover systems, or where seismically induced permanent deformations may result.

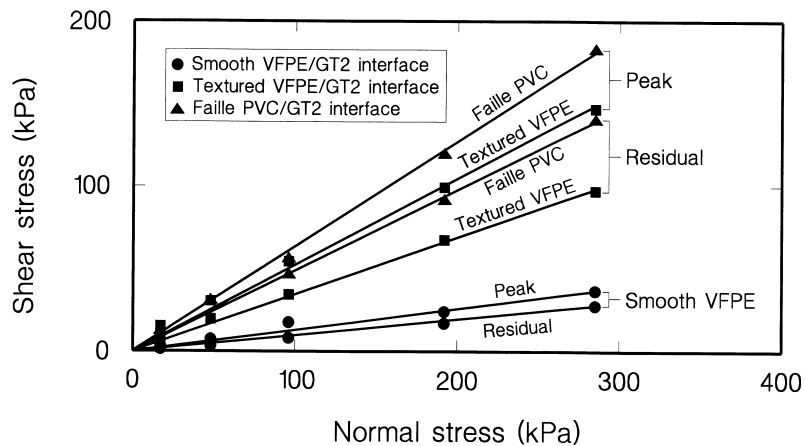
Figure 5. Comparison of failure envelopes for faille PVC, smooth VFPE, and textured VFPE geomembrane-GT2 geotextile interfaces.

VFPE geomembrane-nonwoven geotextile interface shear behavior was also determined in the present study from a series of ring shear tests on the smooth and textured VFPE-GT2 geotextile interfaces. **Figure 5** presents a comparison of the peak and residual failure envelopes for faille PVC, textured VFPE, and smooth VFPE geomembrane-GT2 geotextile interfaces. The failure envelopes indicate that the peak shear strength of this textured VFPE geomembrane interface was less than the faille PVC geomembrane interface. Additionally, this textured VFPE interface experienced a larger post-peak

strength loss than the faille PVC interface because the VFPE geomembrane texturing tore or pulled out more fibers from the nonwoven geotextile during shearing. As expected, the smooth VFPE geomembrane interface exhibited lower peak and residual shear strengths than the faille PVC and textured VFPE geomembrane interfaces. The reason that the smooth VFPE geomembrane interface exhibited a lower peak and residual shear strength than the faille PVC geomembrane interface is the difference in surface pliability. Even though the VFPE geomembrane is more pliable and flexible than an HDPE geomembrane, it is still less pliable than the faille or smooth sides of a PVC geomembrane and, thus, exhibits a lower interface strength.

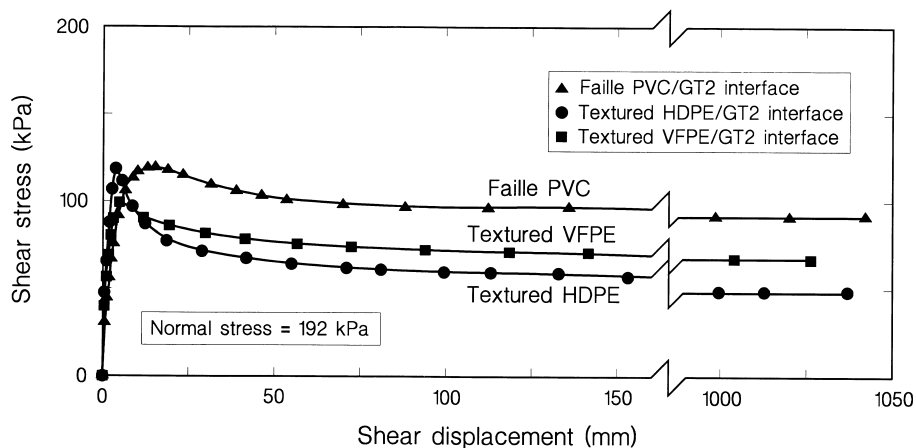
As a final comparison, **Figure 6** presents the shear stress-displacement relationships for faille PVC, textured HDPE, and textured VFPE geomembrane-GT2 geotextile interfaces at a normal stress of 192 kPa. The VFPE and HDPE geomembrane interfaces reached a peak strength condition after approximately 5 mm of shear displacement and then experienced a substantial post-peak strength loss (40 to 60%). On the other hand, the faille PVC interface peaked at a shear displacement of approximately 18 mm and lost only 20 to 25% of its peak shear strength. Additionally, a comparison of Figures 4 and 5 shows that textured HDPE geomembrane interfaces produced higher peak and lower residual failure envelopes than the corresponding textured VFPE geomembrane interfaces. In conclusion, faille PVC geomembrane-nonwoven geotextile interfaces appear to yield similar peak shear strengths and considerably higher residual shear strengths than similar textured HDPE and textured VFPE geomembrane-nonwoven geotextile interfaces.

Figure 6. Comparison of shear stress-displacement relationships for faille PVC, textured HDPE, and textured VFPE geomembrane-GT2 geotextile interfaces.

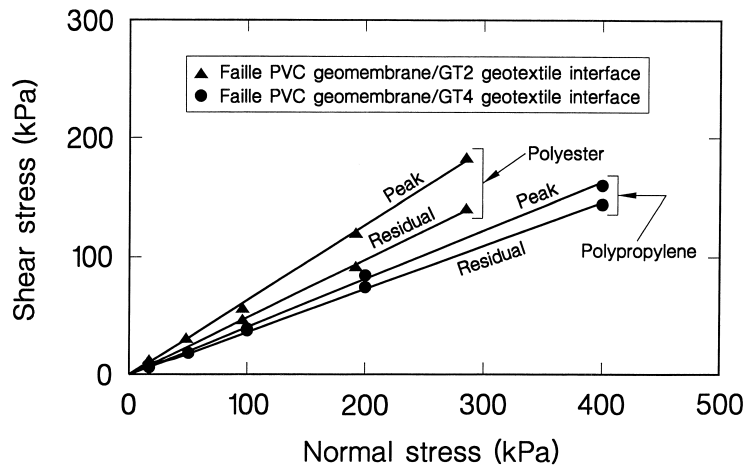
The peak and residual failure envelopes for the two interfaces are presented in **Figure 7**. It is apparent that the PET-based geotextile interface yielded higher peak and residual friction angles than the PP-based geotextile interface. For example, at a normal stress of 200 kPa, the secant peak and residual friction angles for the faille PVC-PET geotextile are 32 and 26°, respectively, while the secant peak and residual friction angles for the faille PVC geomembrane-PP geotextile interface are 23 and 20°, respectively. Polyester-based nonwoven geotextiles were also found to yield higher interface shear strengths than PP-based nonwoven geotextiles when sheared against the textured HDPE geomembrane (Stark et al. 1996). This trend is most likely caused by differences in fiber diameter, hardness, roughness, and weight as well as compositional properties.

Figure 7. Effect of nonwoven geotextile fiber composition on interface shear strength.

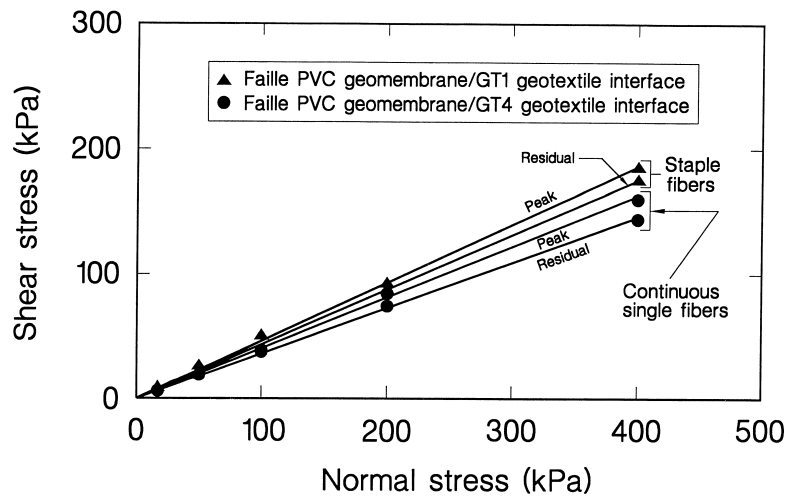
Figure 8. Effect of nonwoven geotextile fiber composition on interface shear strength.

Additionally, two nonwoven, PP geotextiles (GT1 and GT4) were used to determine the effect of geotextile fiber type (staple versus continuous) on the shear strength of faïlle PVC geomembrane interfaces. Both geotextiles are needle punched and have a mass per unit area of 540 g/m^2 . However, the GT1 geotextile utilizes staple fibers while the GT4 geotextile utilizes continuous single fibers. **Figure 8** shows the peak and residual failure envelopes for the faïlle PVC geomembrane-GT1 and GT4 interfaces. The failure envelopes indicate that the staple fiber geotextile yielded greater peak and residual interface strengths when sheared against a faïlle PVC geomembrane. Another important characteristic inferred from Figure 8 is that the staple fiber geotextile did not undergo as large a post-peak strength loss as the continuous single fiber geotextile. A possible explanation for this behavior is that the staple fibers are too small or fine to embed into the PVC geomembrane to the same degree as the longer and larger continuous single fibers. It was observed after shearing that fewer staple fibers were torn out during shear, which enabled the staple fiber geotextile to stay more intact than the continuous single fiber geotextile and prevented the interface from undergoing a large post-peak strength loss. This may be attributed to the continuous single fibers being longer and having more contact area with the PVC geomembrane. The greater contact area may have increased the shear force on the continuous fiber resulting in tearing or pulling out. Once the continuous fiber is removed from the geotextile, it is oriented parallel to the direction of shear. The long nature of the fiber results in a larger reduction in the interface shear resistance than a staple fiber. In addition, the continuous single fibers were able to embed into the PVC geomembrane at high normal stresses, allowing the continuous single fibers to be torn or pulled out and the interface shear strength to decrease as shearing progressed. Thus, the mechanical properties of the fibers appear to influence the PVC geomembrane-nonwoven geotextile shear behavior.

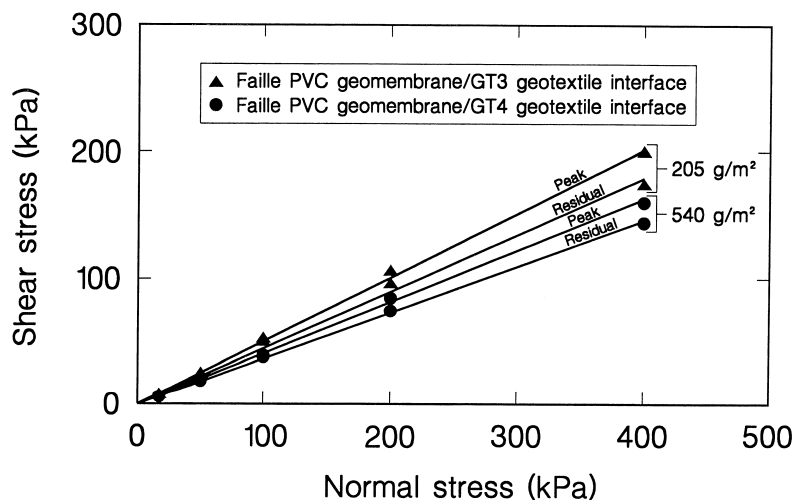
Figure 9. Effect of nonwoven geotextile mass per unit area on interface shear strength.

Two nonwoven, PP geotextiles, one with a mass per unit area of 205 g/m² (GT3) and the other with a mass per unit area of 540 g/m² (GT4), were sheared against a faille PVC geomembrane to examine the effects of mass per unit area on interface shear resistance. Both of the geotextiles are needle punched and have continuous single fibers. The 205 g/m² geotextile yielded a greater interface shear resistance than the 540 g/m² geotextile, as indicated by the failure envelopes of **Figure 9**. For example, at a normal stress of 200 kPa, the 205 g/m² geotextile interface exhibited secant peak and residual friction angles of 28 and 25°, respectively, compared to 23 and 20°, respectively, for the 540 g/m² geotextile. This may be caused by the fibers of the 540 g/m² geotextile being more easily torn or pulled out during shear than the fibers of the 205 g/m² geotextile and the increased number of fibers in the heavier geotextile placing more fibers in contact with the surface of the PVC geomembrane. The increased number of fibers in contact with the surface of the PVC geomembrane increases the number of fibers that can actually be removed from the geotextile. Once a fiber is removed, it is oriented parallel to the direction of shear, which reduces the interface shear resistance. Therefore, the mass per unit area appears to slightly influence the faille PVC geomembrane-nonwoven geotextile interface shear strength.

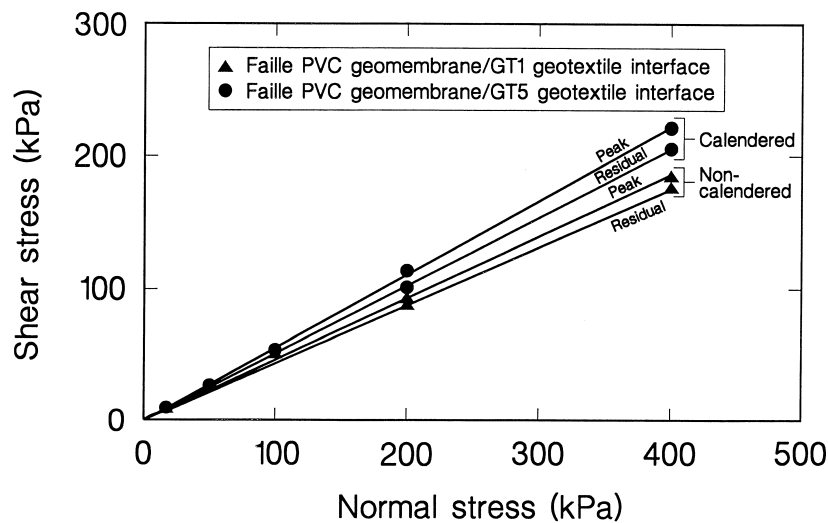
textile (GT5). This geotextile possesses the same properties as the GT1 nonwoven geotextile except that it is calendered. The peak and residual failure envelopes for the faille PVC geomembrane-GT5 and -GT1 geotextile interfaces are shown in **Figure 10**. It can be seen that the calendered geotextile interface yielded larger peak and residual interface shear strengths than the non-calendered geotextile. This trend is attributed to the surface of the calendered geotextile being rougher and more rigid than that of the non-calendered geotextile. This roughness and rigidity may enable the calendered geotextile to embed into the PVC geomembrane to a greater degree and prevent the fibers from being pulled or torn out and oriented parallel to the direction of shear. Additionally, the calendered geotextile, like the non-calendered geotextile, experienced approximately 5% post-peak strength loss at normal stresses of 200 and 400 kPa and no post-peak strength loss at normal stresses between 17 and 100 kPa. This behavior is probably due to the rough surface of the calendered geotextile being smoothed at high normal stresses, thereby causing some loss of shear strength. The smoothing of the calendered geotextile at high normal stresses was determined by visually comparing the original/presheared material with the calendered geotextile after shearing to the residual condition. It could be seen that some of the matted finish of the original calendered geotextile had been removed resulting in a more pliable surface. However, at lower normal stresses, the calendered surface is not smoothed significantly, which accounts for the absence of a post-peak strength loss. In summary, nonwoven geotextile calendering appears to have an impact on peak and residual interface shear strengths.

Figure 10. Effect of nonwoven geotextile calendering on interface shear strength.

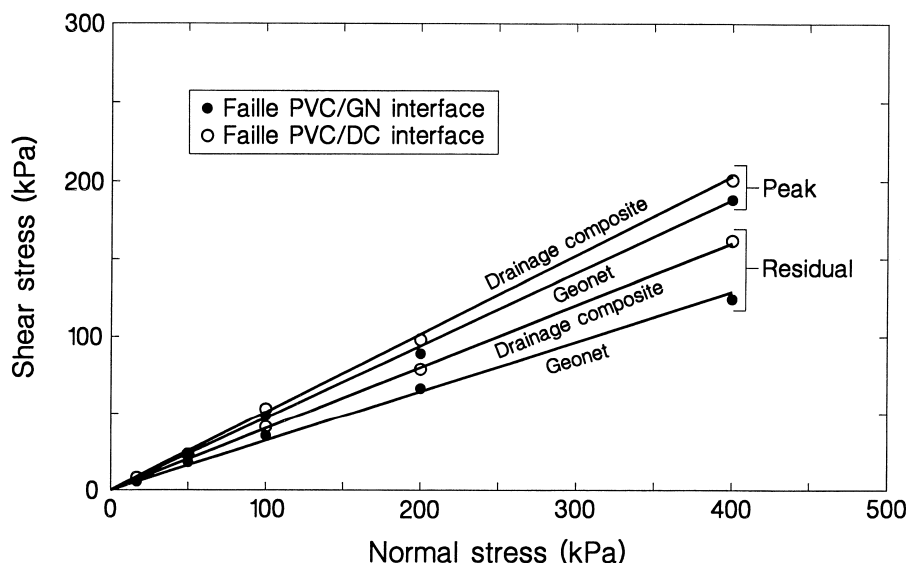
The failure envelopes in Figure 11 also show the effect of having a nonwoven geotextile between the PVC geomembrane and the geonet in a drainage composite interface.

Figure 11. Comparison of failure envelopes for faille PVC geomembrane-drainage composite and -geonet interfaces.

This geotextile is the same as the GT2 geotextile except the mass per unit area is 270 g/m² instead of 540 g/m². It can be seen that the faille PVC geomembrane-drainage composite interface yielded average peak and residual friction angles of approximately 27 and 22°, respectively. The corresponding values for the faille PVC geomembrane-geonet interface are approximately 25 and 20°, respectively. To explain this difference, it is noted that the faille PVC geomembrane-GT2 interface yielded substantially higher interface strengths (average peak and residual friction angles of 32 and 26°, respectively) than the faille PVC geomembrane-drainage composite interface. The higher interface shear strengths for the PVC geomembrane-GT2 interface than the drainage composite interface is attributed to the larger contact area for the GT2 geotextile versus the area corresponding to the geonet in the drainage composite. The higher shear strength of the faille PVC geomembrane-drainage composite interface versus the geonet interface is attributed to the higher frictional resistance for the faille PVC geomembrane-nonwoven GT2 interface than the faille PVC geomembrane-HDPE geonet interface.

Drainage composites and geonets are commonly used to facilitate lateral drainage in landfill liner and cover systems and other applications. Therefore, the shear behavior of PVC geomembrane-drainage composite and geonet interfaces was examined in this study. As discussed previously, the drainage composite and geonet have two and one nonwoven geotextiles, respectively, heat-bonded to the geonet. **Figure 11** presents a comparison of the peak and residual failure envelopes for faille PVC geomembrane-drainage composite and geonet (without a geotextile in contact with the PVC geomembrane) interfaces. The drainage composite and geonet interfaces exhibited a 20 and 45% post-peak strength loss, respectively, at a normal stress of 400 kPa. This strength loss is higher than the post-peak strength losses observed for the various PVC geomembrane-nonwoven geotextile interfaces. One of the reasons for these larger strength losses is that the relatively rigid geonet embedded in the soft PVC geomembrane surface under all of the applied normal stresses. Thus, as interface shearing began, relatively high shear stresses were required to dislodge the geonet from its initial embedded position. Once the geonet had been dislodged, it sheared across the surface of the PVC geomembrane without being able to embed, thereby resulting in a significant amount of post-peak strength loss.

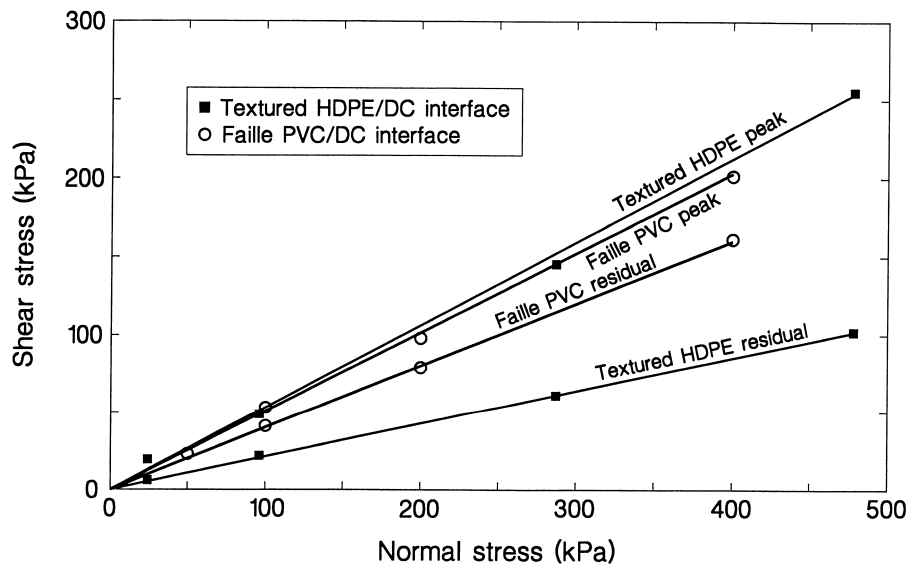
Figure 12 presents the failure envelopes for textured HDPE and faille PVC geomembrane-drainage composite interfaces. As was the case for the nonwoven geotextile interfaces, the faille PVC geomembrane interface exhibited a peak shear strength similar to that of the textured HDPE geomembrane interface. Also, a larger post-peak strength loss (50 to 60%) was observed for the textured HDPE interface than for the

Figure 12. Comparison of failure envelopes for textured HDPE and faille PVC geomembrane-drainage composite interfaces.

faillie PVC interface (30 to 35%). Since a geonet cannot substantially embed in a HDPE geomembrane at normal stresses under 500 kPa (Stark et al. 1996), the same mechanisms responsible for the large post-peak strength losses in textured HDPE geomembrane-nonwoven geotextile interfaces probably produce a similar shear behavior in textured HDPE geomembrane-drainage composite interfaces. In addition, the geonet damages and smooths the asperities of the textured HDPE geomembrane during shearing, thereby decreasing the roughness of the textured surface and further reducing the interface strength. However, the surface of a faille PVC geomembrane was actually roughened by the geonet as shearing progressed. This was determined by visually comparing the sheared PVC geomembrane to a piece of the original material.

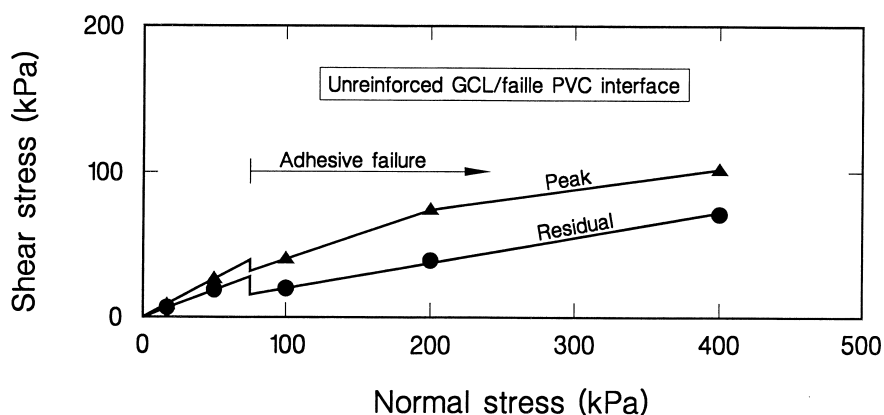
A GCL can be used in landfill cover and liner systems to partially or completely replace a compacted clay liner. A faille PVC geomembrane was sheared against an unreinforced GCL to determine the shear behavior of this interface. As mentioned previously, the GCL was not allowed to hydrate. **Figure 13** presents the results of shear tests performed on the unreinforced, smooth HDPE geomembrane-backed GCL-faille PVC geomembrane interface. At a normal stress between 50 and 100 kPa, the critical shear surface shifted from the dry bentonite-faille PVC geomembrane interface to the

Figure 13. Peak and residual failure envelopes for an unreinforced, smooth HDPE geomembrane-backed GCL-faille PVC geomembrane interface.

smooth HDPE geomembrane backing-dry bentonite interface. In other words, at normal stresses greater than approximately 100 kPa, the unreinforced GCL experienced an internal adhesive failure because the adhesive bonding the dry bentonite to the smooth geomembrane backing failed in shear. This behavior was also observed by Eid and Stark (1997) for an unreinforced, smooth HDPE geomembrane-backed GCL-textured HDPE geomembrane interface. An adhesive failure takes place when the adhesive used to bond the dry bentonite to the smooth geomembrane backing is weaker in shear than the dry bentonite-faille PVC geomembrane interface. Therefore, the failure surface shifts to the bottom of the unreinforced bentonite layer and the peak and residual friction angles decrease, as indicated by the discontinuities in the failure envelopes shown in Figure 13. At normal stresses of 50 kPa and below, the adhesive does not fail and the interface has average peak and residual friction angles of 27 and 21°, respectively. When an adhesive failure occurs at a normal stress between 50 and 100 kPa, the average peak and residual friction angles are reduced to 17 and 11°, respectively. In summary, the unreinforced, smooth HDPE geomembrane-backed GCL-faille PVC geomembrane interface strength is stress dependent and this characteristic should be considered in the design process. For example, a typical landfill cover system is subjected to normal stresses less than 50 kPa, which suggests that failure will occur at the dry bentonite-PVC geomembrane interface. However, an adhesive failure may occur in a landfill liner system since normal stresses on a liner usually exceed 100 kPa.

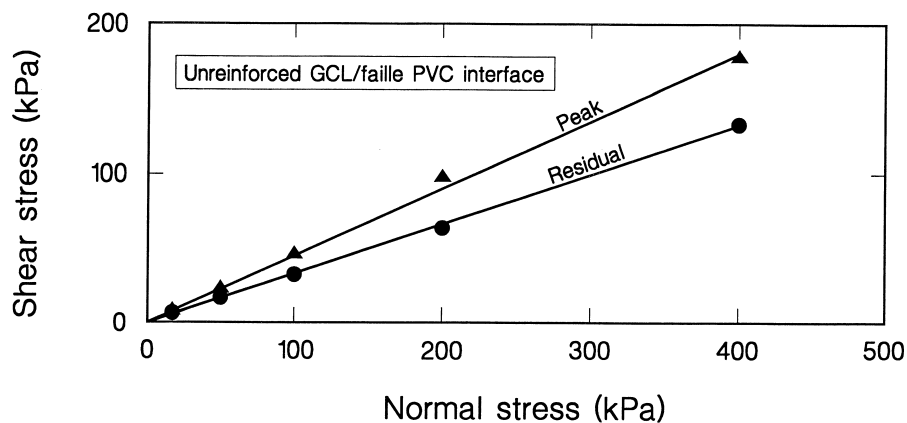
The unreinforced GCL discussed in the previous paragraph is also manufactured with a textured HDPE geomembrane backing. The unreinforced, textured HDPE geomembrane-backed GCL-faille PVC geomembrane interface was tested to determine if a textured geomembrane backing has an effect on the interface failure mode and shear strength. The peak and residual failure envelopes for this interface are presented in Figure 14. It can be seen that the textured geomembrane backing prevented an adhesive failure from occurring at normal stresses ranging from 17 to 400 kPa. To verify this

Figure 14. Peak and residual failure envelopes for an unreinforced, textured, HDPE geomembrane-backed GCL-faille PVC geomembrane interface.

conclusion, the secant peak and residual friction angles at a normal stress of 400 kPa for the unreinforced, textured geomembrane-backed GCL-faille PVC geomembrane interface are 24 and 18°, respectively. However, the corresponding values are only 14 and 10°, respectively, for the unreinforced, smooth geomembrane-backed GCL interface. To experience an adhesive failure with a textured geomembrane backing, the dry bentonite particles would have to shear over the asperities of the geomembrane, which would require a shear stress greater than the shear strength of the dry bentonite-faille PVC geomembrane interface. Therefore, a textured HDPE geomembrane backing increases interface shear strengths at normal stresses greater than approximately 100 kPa by mobilizing a larger shear resistance between the geomembrane backing and the dry bentonite. This helps to prevent an adhesive failure in the unreinforced GCL for normal stresses less than and equal to 400 kPa. This differs from results presented by Stark and Eid (1997) for the unreinforced, textured HDPE geomembrane-backed GCL-textured HDPE geomembrane interface, as discussed below.

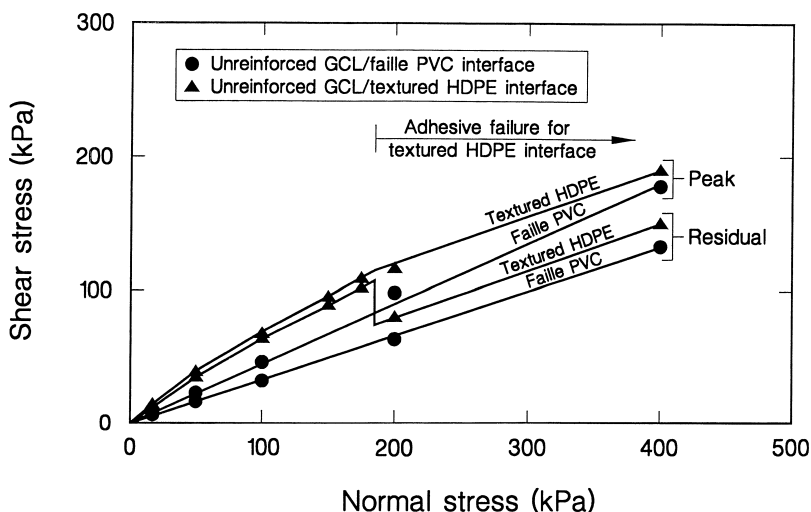
A comparison of peak and residual failure envelopes for the unreinforced, textured HDPE geomembrane-backed GCL-faille PVC and textured HDPE geomembrane interfaces is presented in **Figure 15**. This illustrates the effect of the encapsulating geomembrane on the shear behavior of the unreinforced GCL. The textured HDPE geomembrane interface mobilizes a slightly higher shear strength than the faille PVC geomembrane interface at normal stresses less than approximately 175 kPa. This is

Figure 15. Comparison of failure envelopes for unreinforced, textured HDPE geomembrane-backed GCL-faille PVC and textured HDPE geomembrane interfaces.

probably caused by the asperities of the textured HDPE geomembrane embedding into the dry bentonite layer of the GCL. As shearing begins, a relatively high shear stress must develop to shear the asperities over the dry bentonite particles. The faille PVC geomembrane is relatively smooth and flexible compared to the textured HDPE geomembrane, and it does not embed into the dry bentonite layer to the extent of the textured HDPE geomembrane. Thus, the faille PVC geomembrane did not develop as much frictional resistance when sheared over the unreinforced GCL. Also, as discussed above, the unreinforced, textured geomembrane-backed GCL-faille PVC geomembrane interface did not experience an adhesive failure for normal stresses of 400 kPa and below. However, at normal stresses above roughly 175 kPa, an adhesive failure occurred in the unreinforced, textured geomembrane-backed GCL-textured HDPE geomembrane interface (Eid and Stark 1997). The faille PVC geomembrane mobilizes less shear resistance with the dry bentonite, which does not allow enough shear stress to develop to cause an adhesive failure. However, the textured HDPE geomembrane possesses a greater shear resistance with the dry bentonite, enabling the shear stress required for an adhesive failure to develop. As a result, the adhesive failure in the unreinforced GCL-textured HDPE geomembrane interface reduces the peak and residual shear strengths so, at normal stresses greater than approximately 175 kPa, the unreinforced, textured HDPE geomembrane-backed GCL-textured HDPE and faille PVC geomembrane interfaces yield similar peak and residual friction angles.
